SAND2000-0091

# **MEMS Reliability: Infrastructure, Test Structures, Experiments, and Failure Modes**

## **Summary of work for LDRD: Integrated Approach to Develop MEMS Reliability Tools**

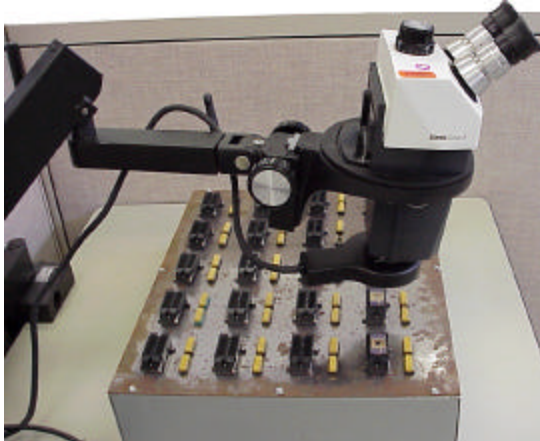
**Figure 1.2.1.** Original multi-device MEMS test system using biological-type microscope.

A first generation multi-part MEMS test station was created before this LDRD was started. The original system is shown in Figure 1.2.1. This system consisted of a custom test fixture to hold the devices and a biological-type microscope. This system suffered from many shortcomings. Focus changed as the operator removed their hands from the microscope. Quality images were almost impossible to acquire due to non-coaxial lighting and room vibrations were amplified through the cantilevered arm of the microscope. A greatly improved system was needed. This system became known as SHiMMeR (Sandia High Volume Measurement of Micromachine Reliability) [1].

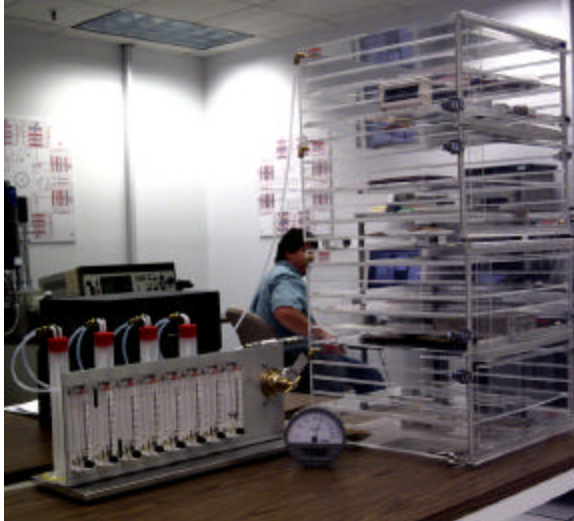
**Figure 1.4.1.** Three of the humidity controlled storage boxes.

Six plexiglas containers (Figure 1.4.1) manufactured by Plas Labs are currently used. Five of the boxes are configured as dry storage only. The sixth box has the capacity to control the humidity. Humidity is controllable from 0% to 100% RH, however condensation will occur at very high RH levels. All of the boxes are purged using dry nitrogen via individual flow meters. Purge rates are continuously variable from 0.1 to 3.0 cubic feet per hour (CHF).

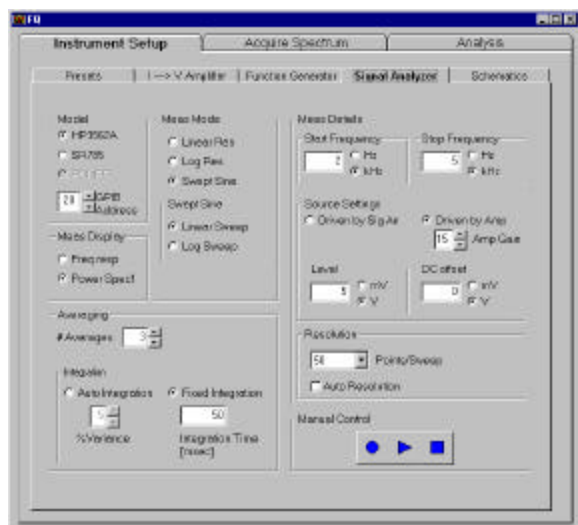
**Figure 1.7.8.** “Signal analyzer” window contains all of the settings important for making resonant frequency measurements.

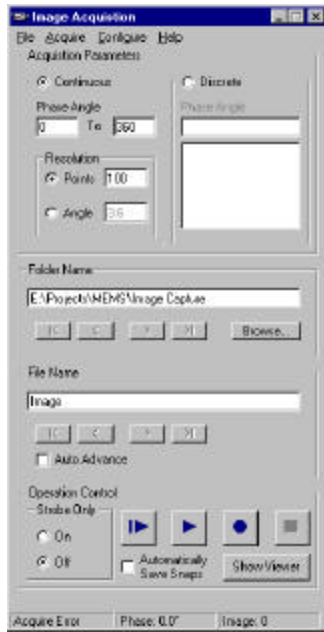
**Figure 1.8.2.** Screen shot of image capture controls.

Software that allows the computer to control this image capture system has been developed (Figure 1.8.2). It allows images to be captured from both rotary and linear motion devices. The images can be either be viewed continuously in slow motion or a sequence can be saved to disk. It has the capability to automatically generate unique names for each device under investigation. Individual frames can be captured and stored through the software's built-in viewer.

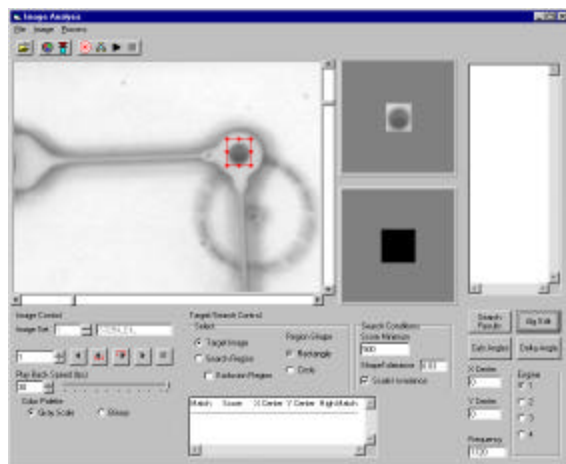
**Figure 1.8.3.** Screen shot of image analysis program.

Once a series of image has been acquired, information must be extracted from them. A tool for analyzing the images has been created. This computer program (Figure 1.8.3) allows the images to be played backed at various frame rates. Binary threshold and image morphology tools are supported. Image tools have been created that can track the motion of a user-defined object in each of the images that was taken with the image

capture software. These initial data points can be used to determine theta versus time and angular error measurements [11]. The theta versus time measurement is used to evaluate constant rotational velocity. The angular error measurement can be used to determine how well the device is tracking the drive signal. This information can be further evaluated to determine a coefficient of friction.
